S-IVB/V AUXILIARY PROPULSION  
SYSTEM 90-DAY RECYCLE  
CAPABILITY TEST REPORT,  
MODULE III  
SUPPLEMENT I

DAC-56756A  
MSFC-DRL-021  
LINE ITEM 180  
REVISED: JUNE 1969  
SUPPLEMENT: JULY 1969

PREPARED BY:  
MCDONNELL DOUGLAS ASTRONAUTICS COMPANY  
WESTERN DIVISION  
SATURN S-IVB TEST PLANNING  
AND EVALUATION COMMITTEE

This supplement documents the bladder vendor's (Bell Aerosystems Company) failure analysis on the defective bladder found in Module II. This analysis was documented by Bell Aerosystems Company report number 8400-928017, dated May 12, 1969.

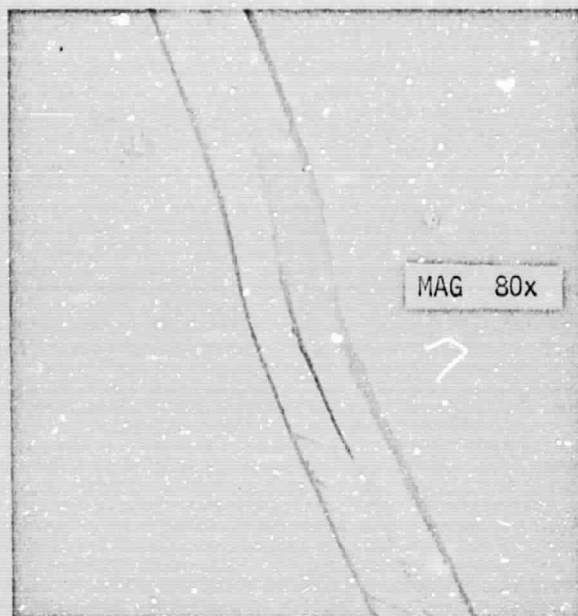
Figure 3-3 shows a section of the outer failure edge showing stress caused by a buckle or fold with resulting initiation of delamination.

Figure 3-3 Microtome Section Through Outer Edge of Failure Area (TFE Layer is on the right)

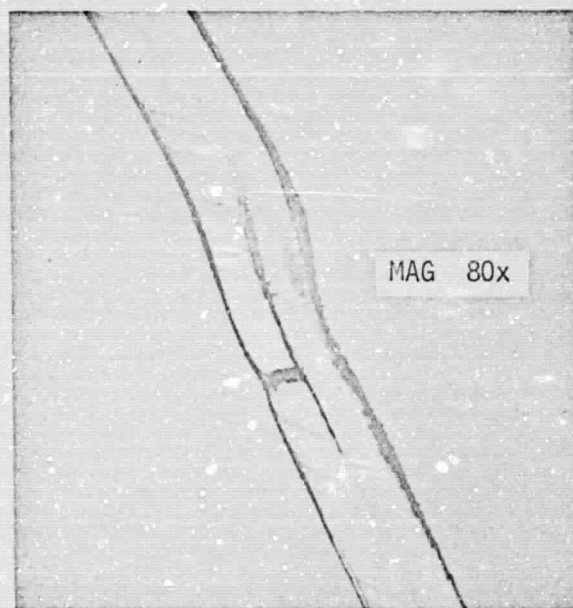
Figure 3-4 shows the initial area of FEP (outer layer) rupture with the TFE (inner layer) still intact. From the TFE edge it is evident that the buckling action imparted a localized twist, and delamination increased in the failure area.

Figure 3-4 Microtome Section through Initial Area of FEP Rupture (TFE Layer is on the right)

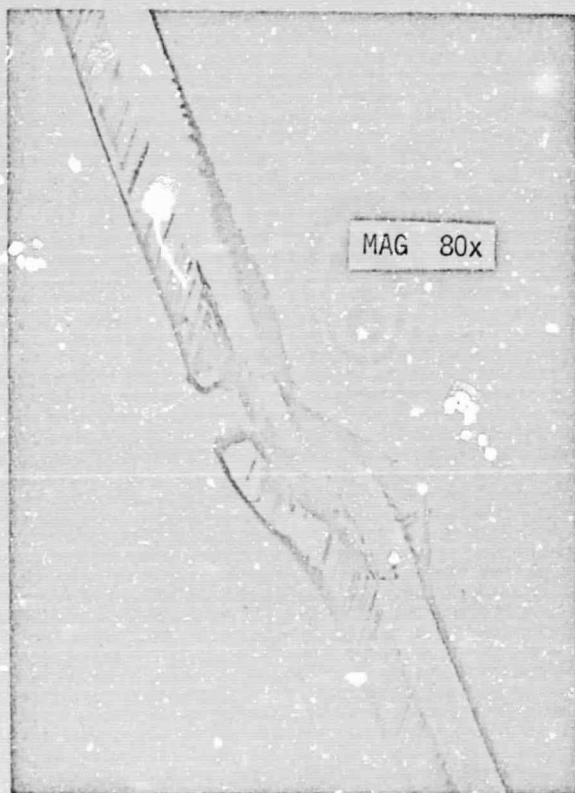
Figure 3-5 shows the section immediately adjacent to the total breakthrough. Localized twist has increased and the TFE is cracked at the end of the delaminated zone. The absence of "necking down" in the TFE layer is typical of rolling fold action in MMH propellant found in repetitive rolling fold tests conducted in laboratory testing on another program by BAC.

Figure 3-5 Microtome Section through Area Immediately Adjacent to Total Rupture (TFE Layer is on the right)

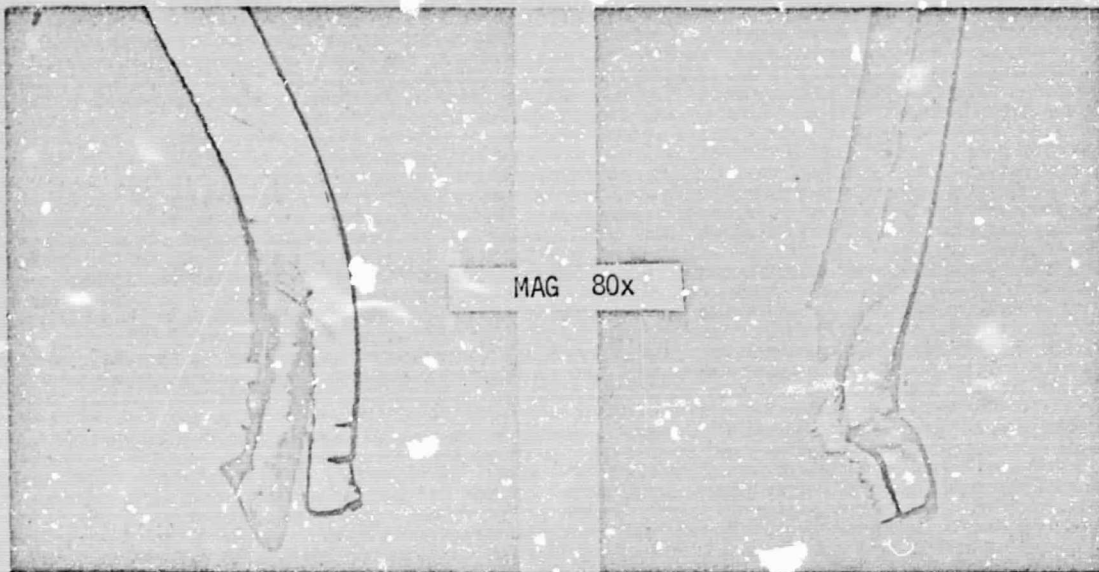
Figure 3-6 Microtome Section through Ruptured Area of S/N 136-3

Figure 3-6 shows the matching total failure microtome sections. The TFE layer failure is abrupt with little thickness reduction and is not aligned with the FEP layer failure. These are the typical characteristics of a break usually associated with stress in either fuel or at low temperature.

(Separate Views are shown of latching Sections of Failure. Note Extensive Delamination and Shear Appearance of TFE Break. TFE Layer on left in each photo.)

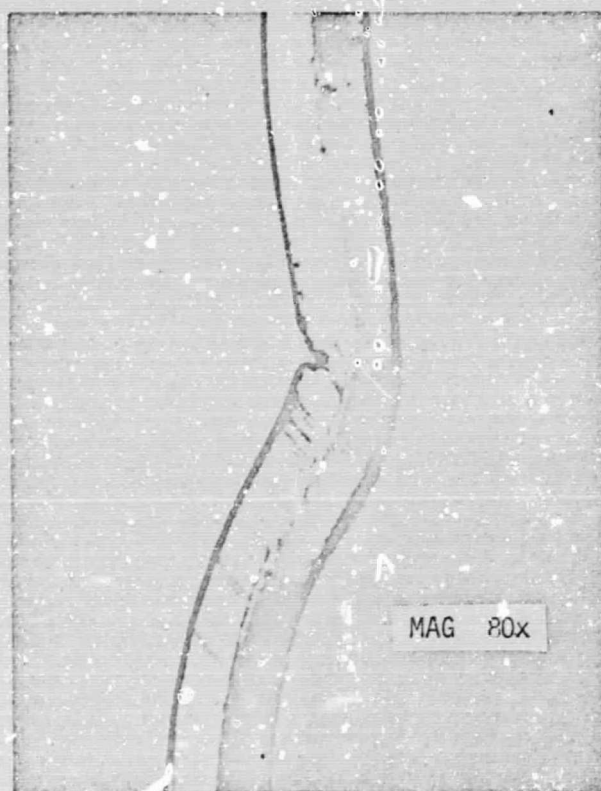
The failure area was then cut from the bladder, mounted, and then sectioned by microtoming. Figures 3-3 through 3-7 show pertinent photomicrographs of the failure section, which are discussed in detail in section 4 of this report.

Figure 3-7 Microtome Section through Initial Area of FEP Rupture. (This area is at opposite end from area shown in Figure 5. TFE Layer is on the right.)
